AD NUMBER	
AD357977	
CLASSIFICATION CHANGES	
TO:	UNCLASSIFIED
FROM:	SECRET
LIMITATION CHANGES	
TO: Approved for public release; distribution is unlimited. Document partially illegible.	
FROM: Distribution authorized to U.S. Gov't. agencies only; Administrative/Operational Use; 1953. Other requests shall be referred to Atomic Energy Commission, Washington, DC. Document partially illegible.	
AUTHORITY	
AEC ltr 16 Jun 1980 ; AEC ltr 16 Jun 1980

The purpose of Signal Corps participation in Project 3.20 was to determine the amounts of thermal flux (cal) and peak overpressure (psi) required to cause severe, moderate, light, and negligible damage to selected signal communications-electronics items of equipment and material for which inadequate or no data existed. Knowing these factors it is believed that responsible signal officers can better plan their tactical communications systems and take passive protective measures to reduce damage and losses to acceptable minimums. These data will also be used to improve design of equipment and material.

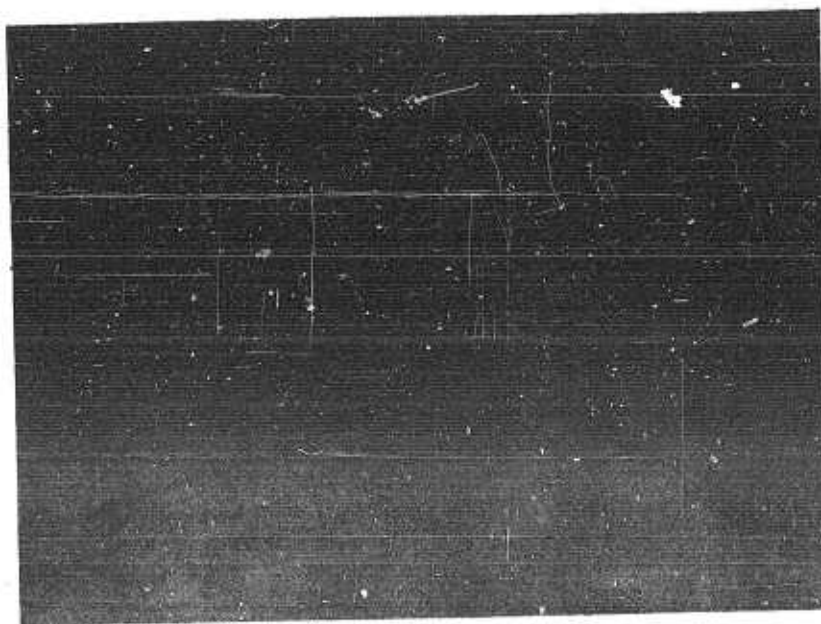
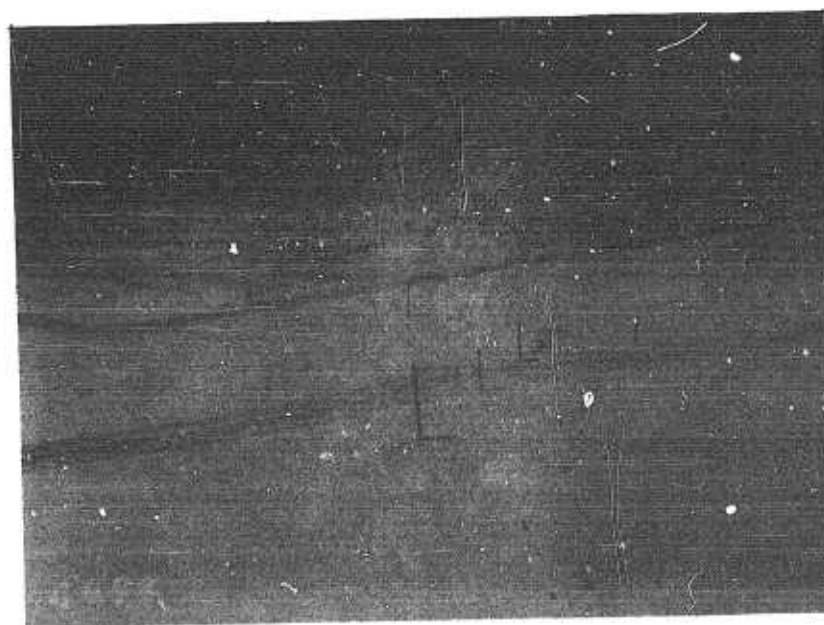
Fig. 3.24 Shot 10, Miscellaneous Aerial Views Test Group 1A, Radial Pole Line. All Views after Shot 10. (Top-from Left to Right Poles D-39 through D-21. Note that Poles D-39 through D-37 are Broken and on the Ground. Also Note that Test Group 6A, 3 Separate Poles (Top Left) are Broken whereas in Test Group 7A (To the Right of Pole D-35) Remained Standing and Received Negligible Damage. Bottom-close up of Poles D-39 through D-35 and Test Group 7A)

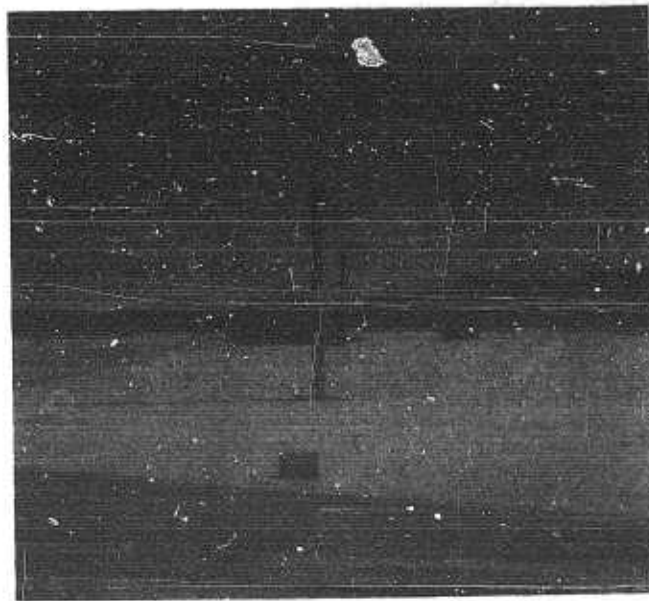
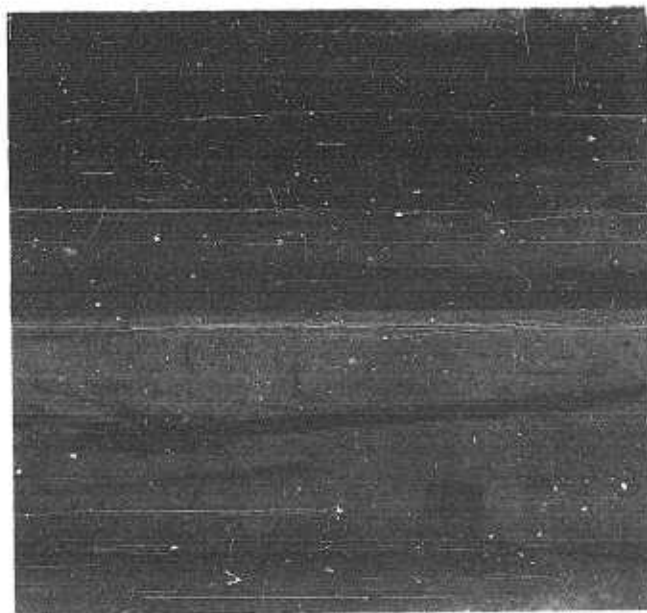
Fig. 3.27 Shot 9, Test Group 24, Transverse Pole Line, Poles C-1 through C-2, C-2 in Foreground. (Top-before, Bottom-after) 3425 ft, 50 cal, 9.6 psi.

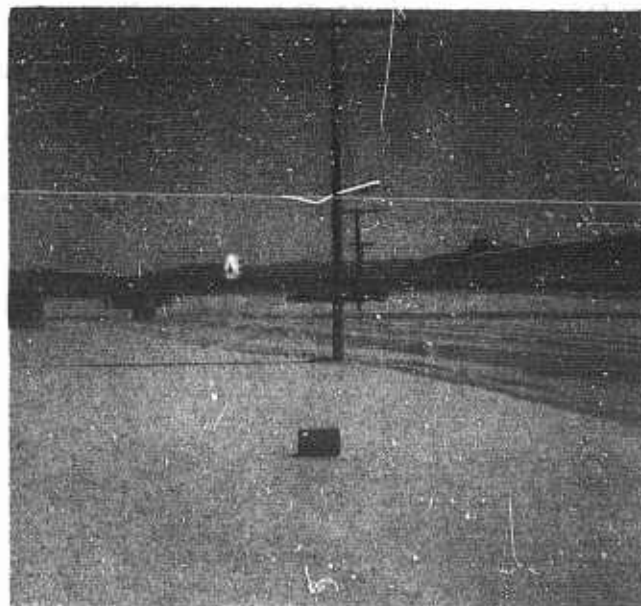
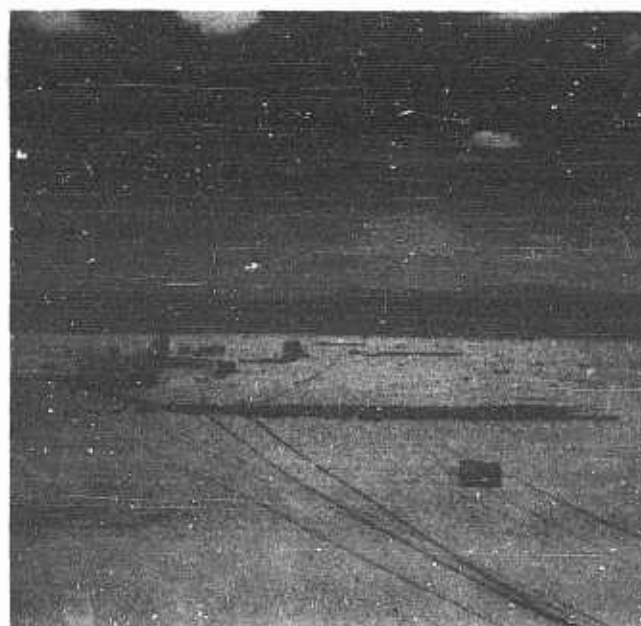
Fig. 3.28 Shot 9, Test Group 24, Transverse Pole Line, Poles C-1 through C-3, C-3 in Foreground. (Top-before, Bottom-after) 3425 ft, 50 cal, 9.6 psi.

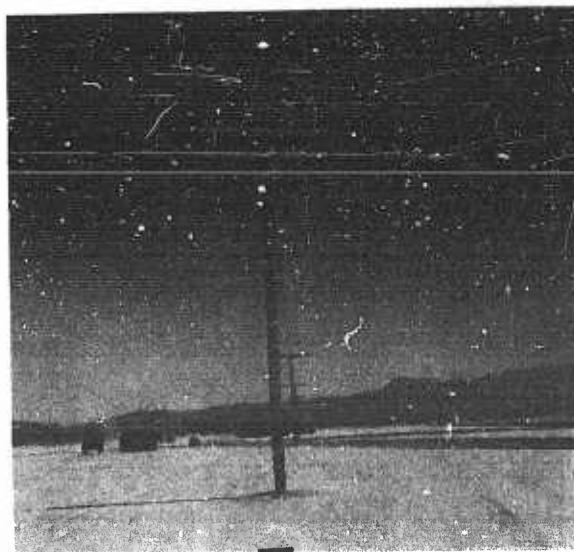
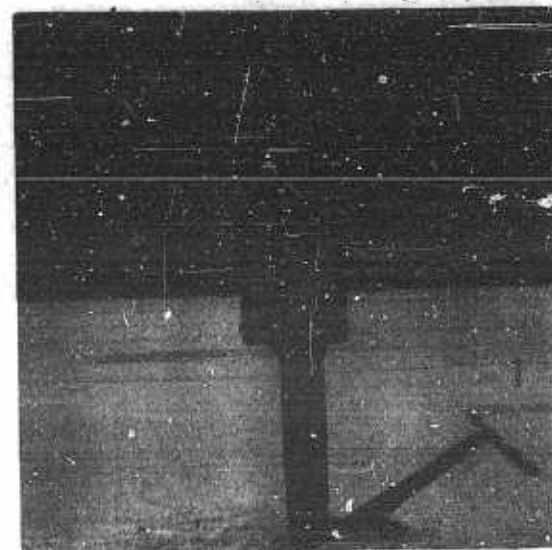
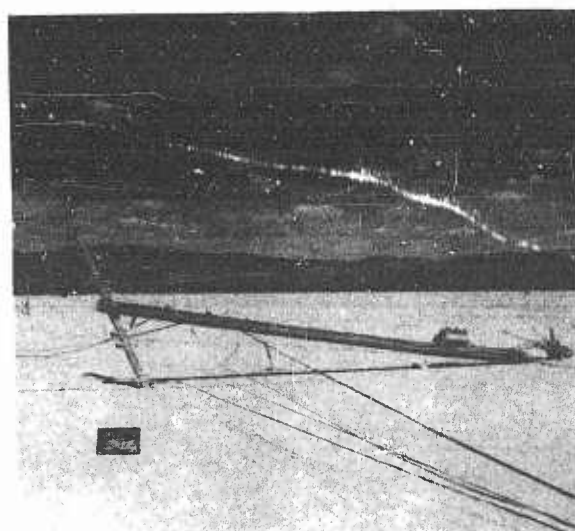
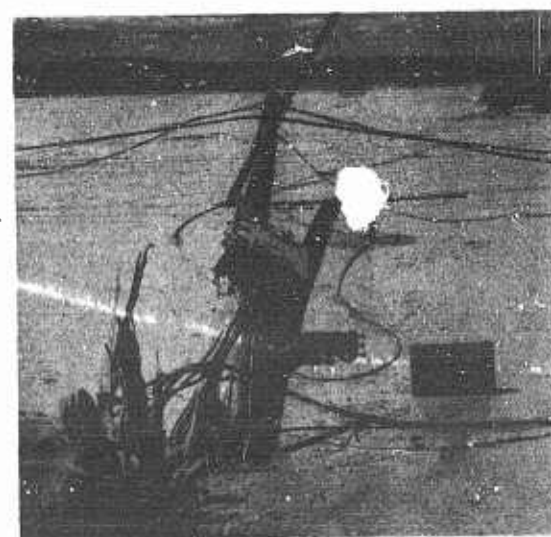
Fig. 3.29 Shot 9, Test Group 24, Transverse Pole Line, Poles C-1 through C-4, C-4 in Foreground. (Top left-before, Bottom left-after, Top right-before, Bottom left-after) Close-ups of Cable Transfer Relay on Pole C-4 (Right). 3425 ft, 50 cal, 9.6 psi.

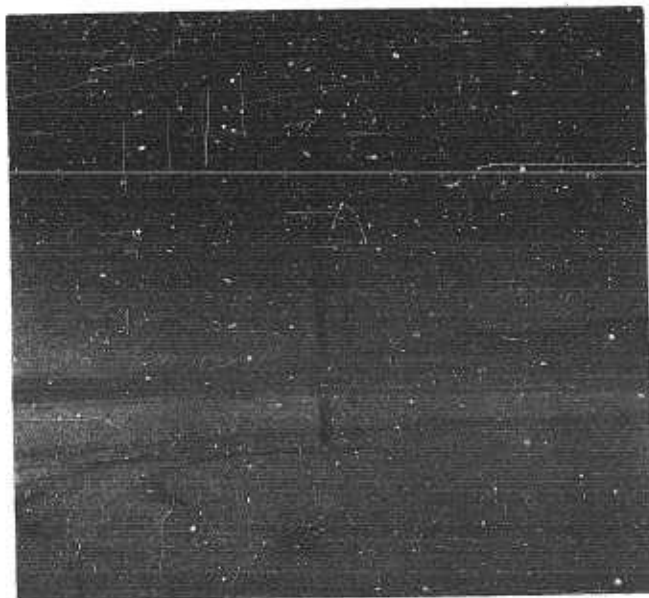
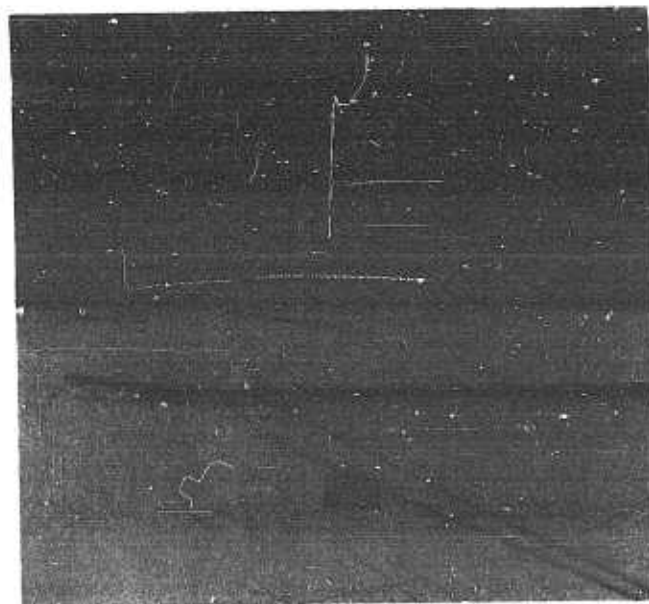
Fig. 3.30 Shot 9, Test Group 24, Transverse Pole Line, Poles C-1 through C-5, C-5 in Foreground. (Top-before, Bottom-after) 3425 ft, 50 cal, 9.6 psi.

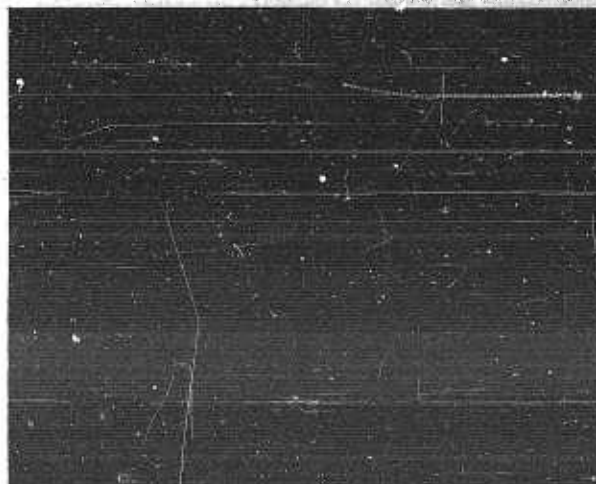
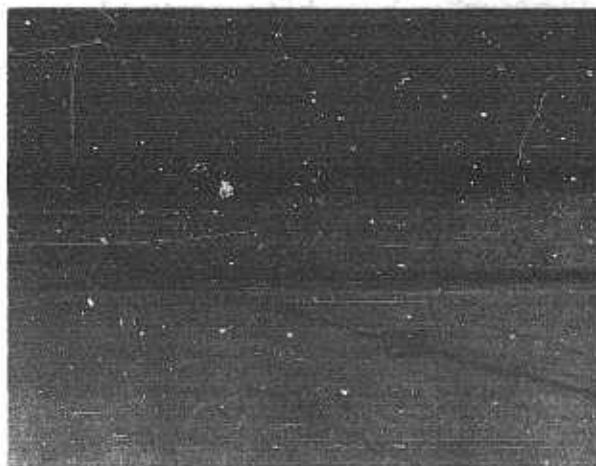
Fig. 3.31 Shot 9, Test Group 24, Transverse Pole Line, Poles C-1 through C-6, C-6 in Foreground. (Top-before, Bottom-after) 3425 ft, 50 cal, 9.6 psi.

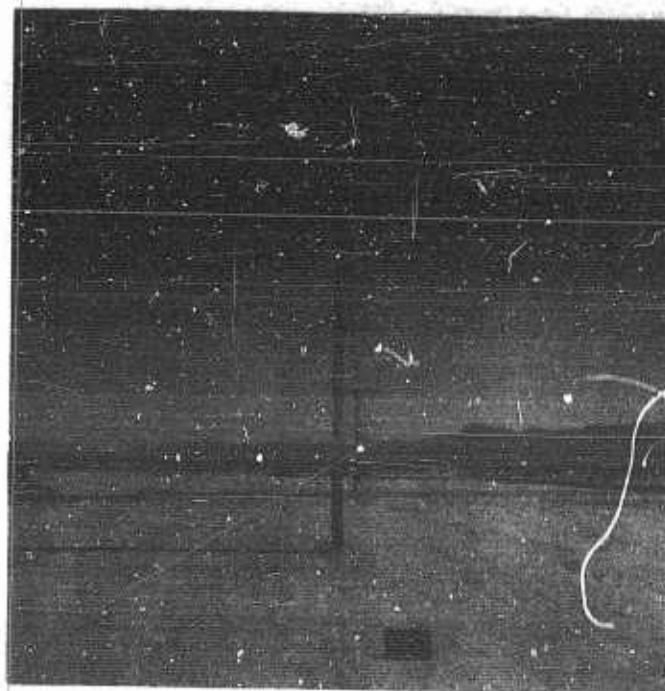
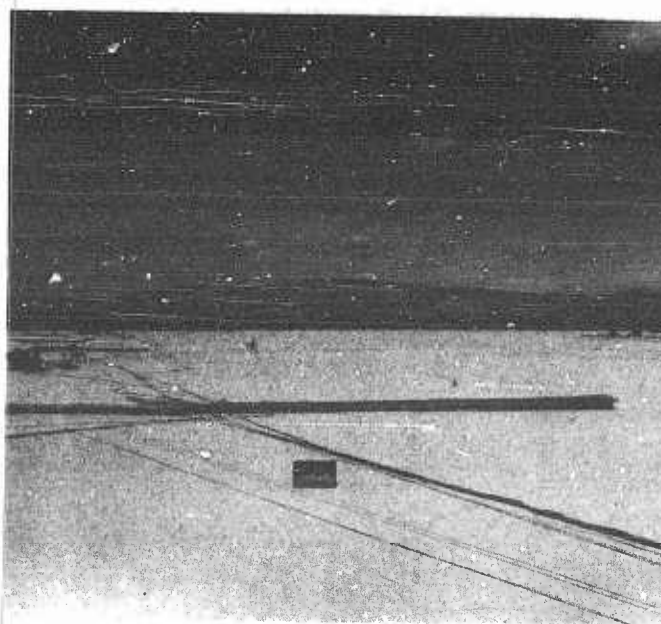
Fig. 3.32 Shot 9, Test Group 24, Transverse Pole Line, Poles C-1 through C-7, C-7 in Foreground. (Top-before, Bottom-after) 3425 ft, 50 cal, 9.6 psi.

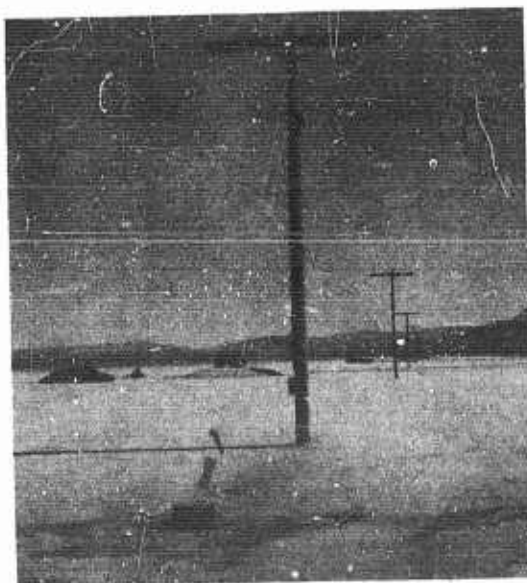
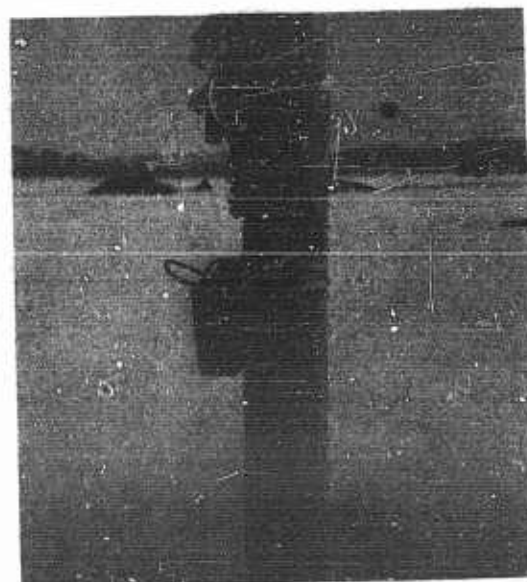
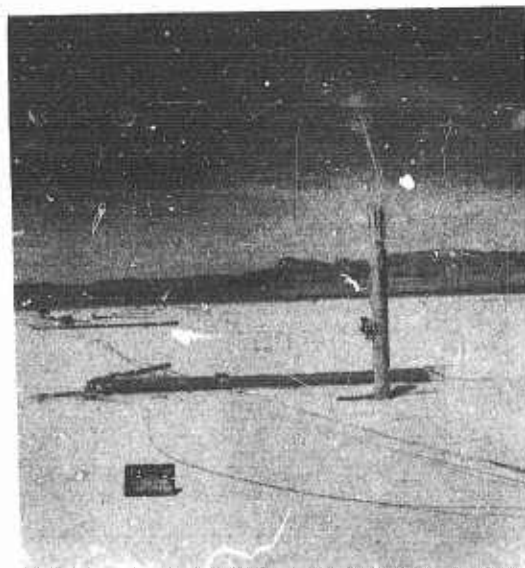
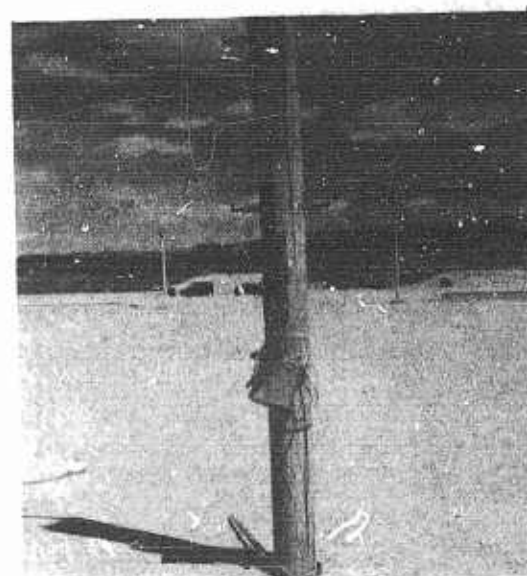
Fig. 3.33 Shot 9, Test Group 24, Transverse Pole Line, Poles C-1 through C-8, C-8 in Foreground. Right Shows Close-ups of EE-8 Telephone and TM-184 Terminal Strip on Shielded Side of Pole C-8. (Top left-before, Bottom left-after, Top right-before, Bottom right-after) 3425 ft, 50 cal, 9.6 psi.

(5) GUYS AND ANCHORS: The triple guys on the two end poles and the anchors were intact and serviceable.

(6) OPEN WIRE: The 104 CS wires although bunched together on the ground were not broken and all would have been useable.

(7) 26 PAIR LEAD COVERED CABLE: This cable was broken in several places and lying on the ground. It remained attached to the messenger on the poles. It received severe damage.

(8) 5 PAIR RUBBER COVERED CABLE: This cable was broken in several places and lying on the ground still attached to the messenger on the poles. It received severe damage.

(9) SPIRAL FOUR CABLE: This cable was broken in several places and lying on the ground attached to the poles. It received severe damage.

(10) FIELD WIRE WD-1/TT: This wire was burned and broken in several places and received severe damage.

(13) FIELD TELEPHONES: The field telephones on poles C-1 and C-8 were shielded from the thermal flux and received no significant thermal or blast damage.

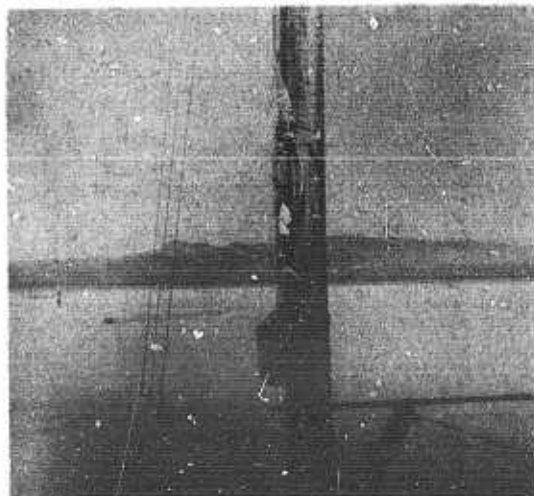
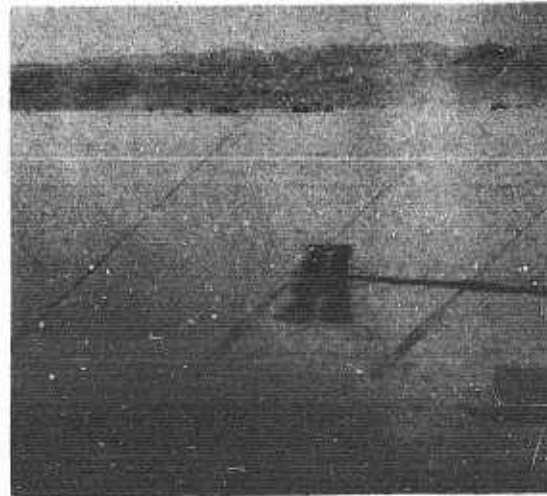
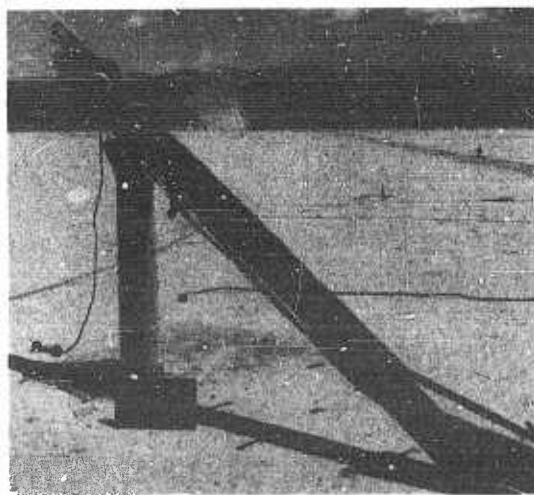
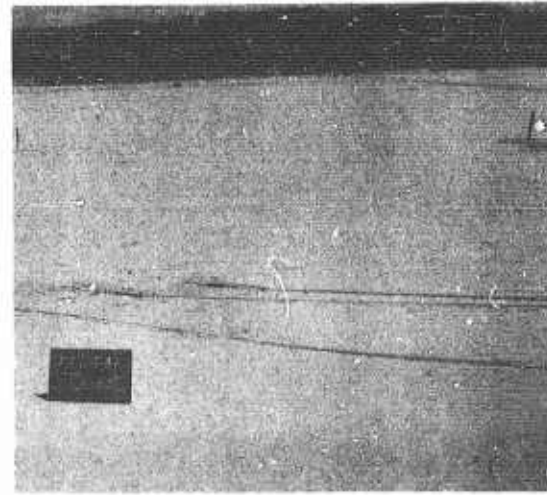
b. RESULTS - This pole line, 1050 ft in length, 4450 ft from GZ, 35 cal, 7.0 psi, received severe damage.

(1) POLES: Poles B-1 through B-7 were broken off with stubs remaining. Pole B-8 remained standing but had a severe bend away from ground zero. The pole itself was unserviceable and would require replacement.

Fig. 3.35 Shot 9, Test Group 27, Transverse Pole Line,
Close-up of Pole B-1. (Top-before, Bottom-after)
4450 ft, 35 cal, 7 psi. Right - Close-ups of Triple
guys on Pole B-1. (Top-before, Bottom-after)

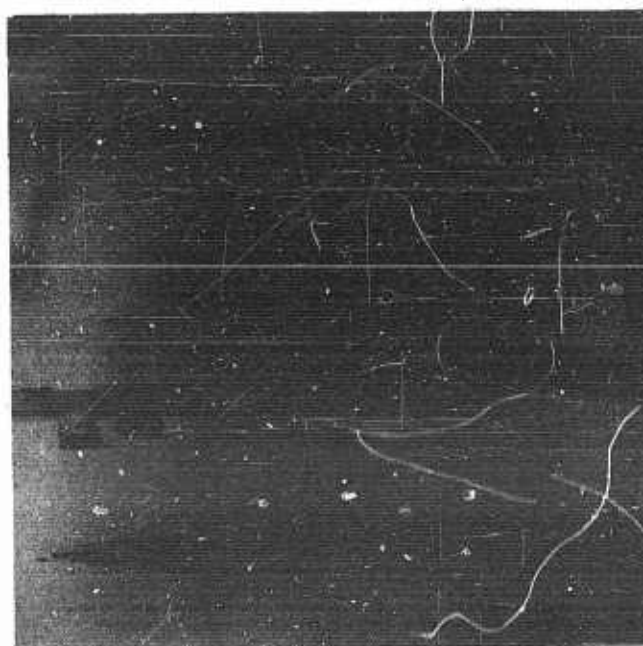
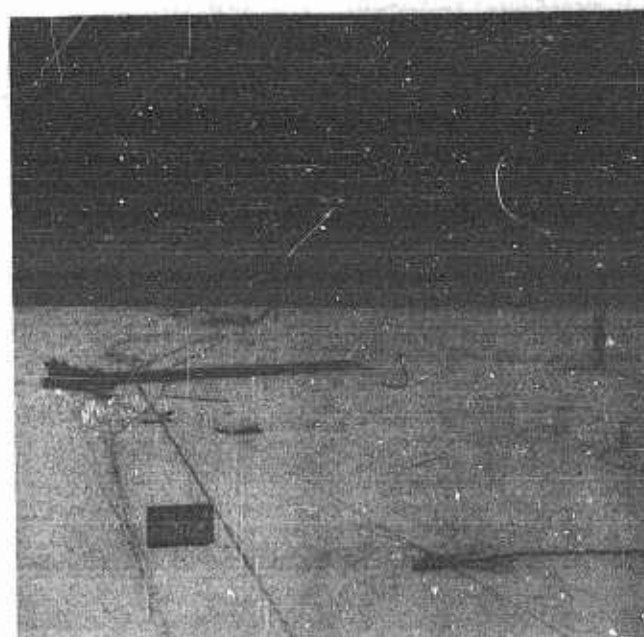
Fig. 3.36 Shot 9, Test Group 27, Transverse Pole Line, Poles B-1 through B-2, B-2 in Foreground. (Top-before, Bottom-after) 4450 ft, 35 cal, 7 psi.

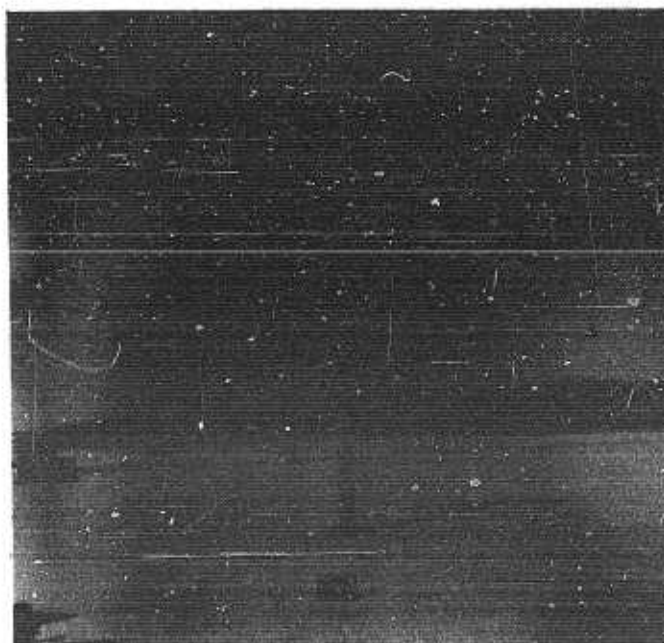
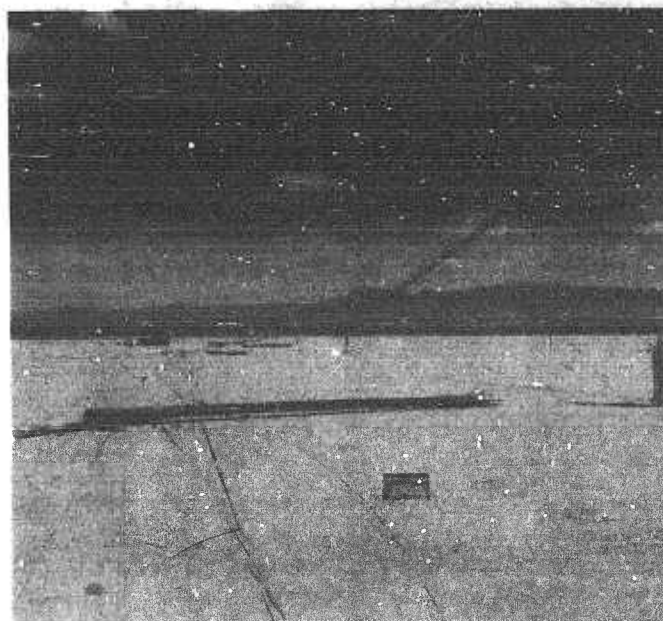
Fig. 3.39 Shot 9, Test Group 27, Transverse Pole Line, Poles B-1 through B-5, B-5 in Foreground. (Top-before, Bottom-after) 4450 ft, 35 cal, 7 psi.

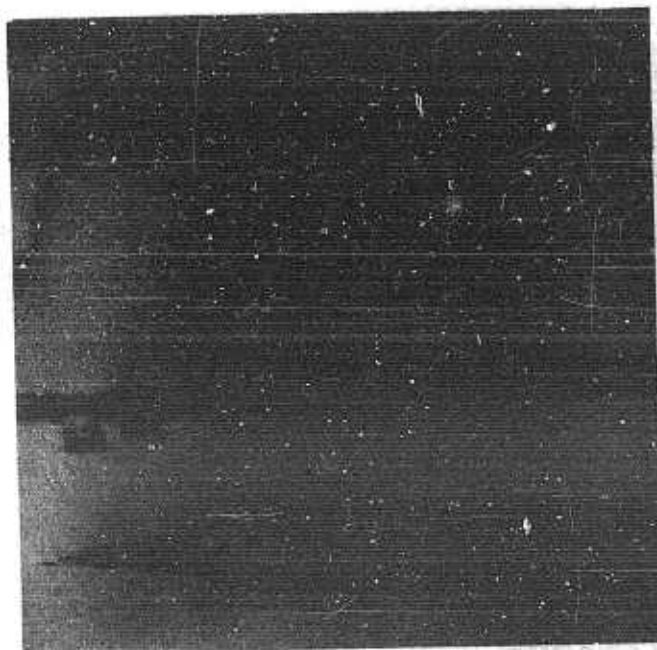
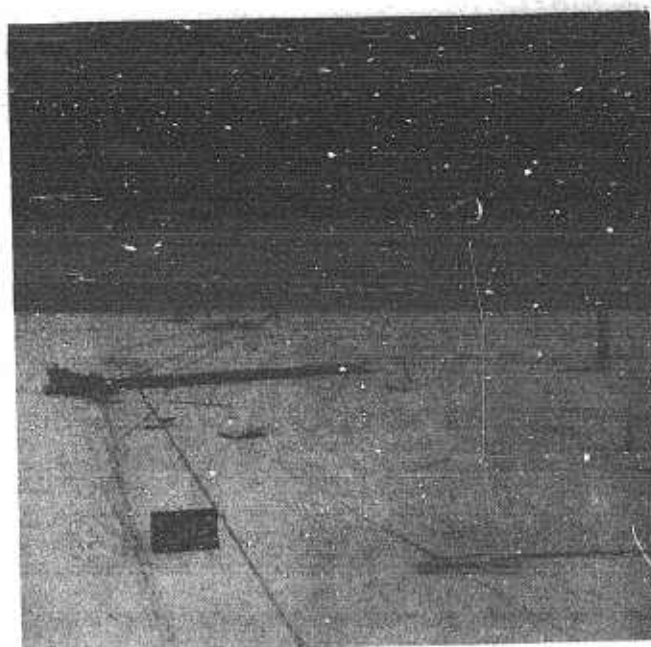
Fig. 3.36 Shot 9, Test Group 27, Transverse Pole Line, Poles B-1 through B-2, B-2 in Foreground. (Top-before, Bottom-after) 4450 ft, 35 cal, 7 psi.

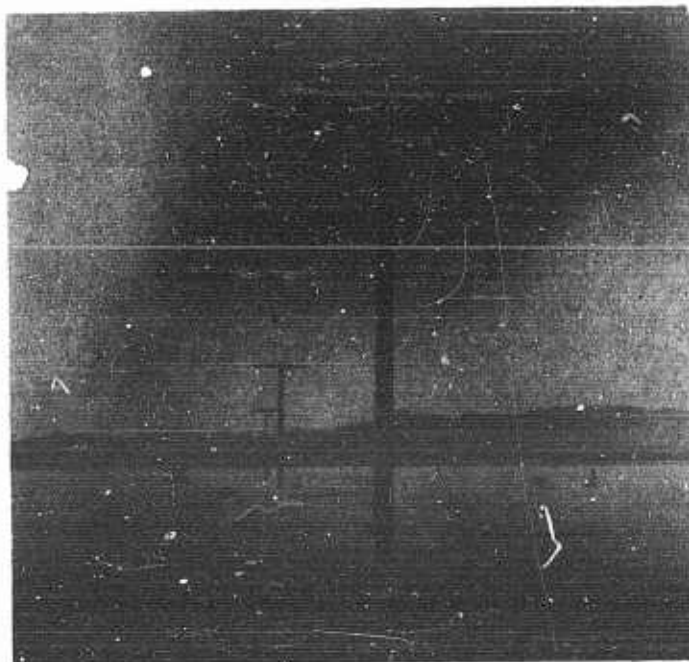
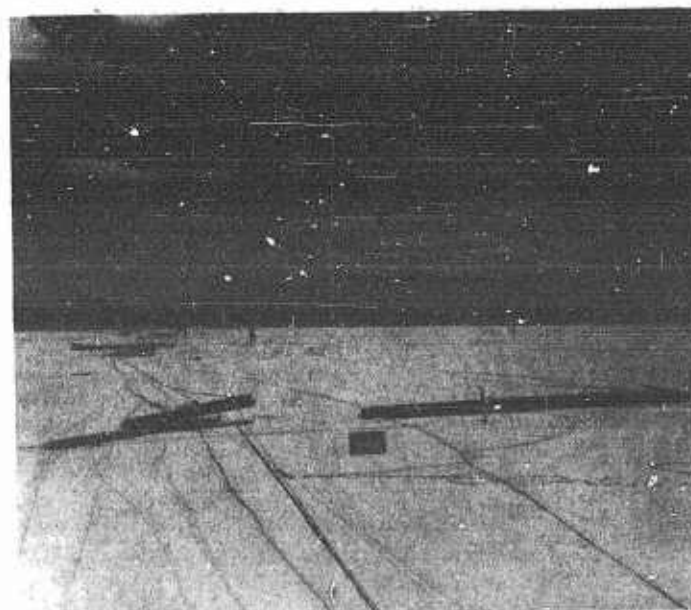
Fig. 3.37 Shot 9, Test Group 27, Transverse Pole Line, Poles B-1 through B-3, B-3 in Foreground. (Top-before, Bottom-after) 4450 ft, 35 cal, 7 psi.

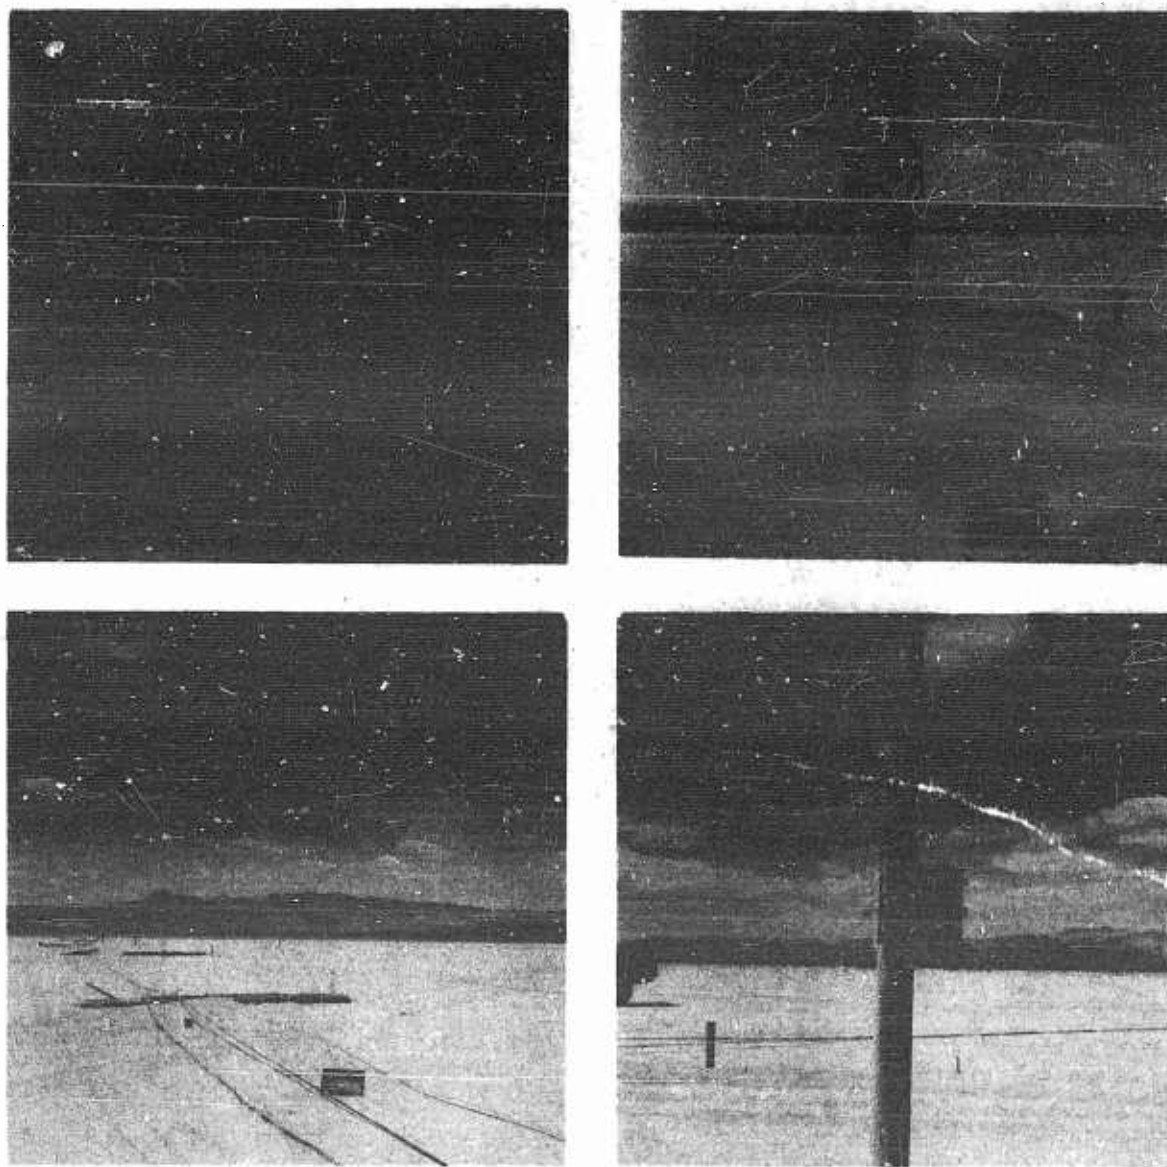
Fig. 3.38 Shot 9, Test Group 27, Transverse Pole Line, Poles B-1 through B-4, B-4 in Foreground. Right Shows Close-ups of Cable Transfer Relay on Pole B-4. (Top left-before, Bottom left-after, Top right-before, Bottom right-after) 4450 ft, 35 cal, 7 psi.

(10) CABLE TRANSFER RELAY: This relay sustained no significant thermal or blast damage. A laboratory analysis performed on this relay shows that there was no electrical or structural damage.

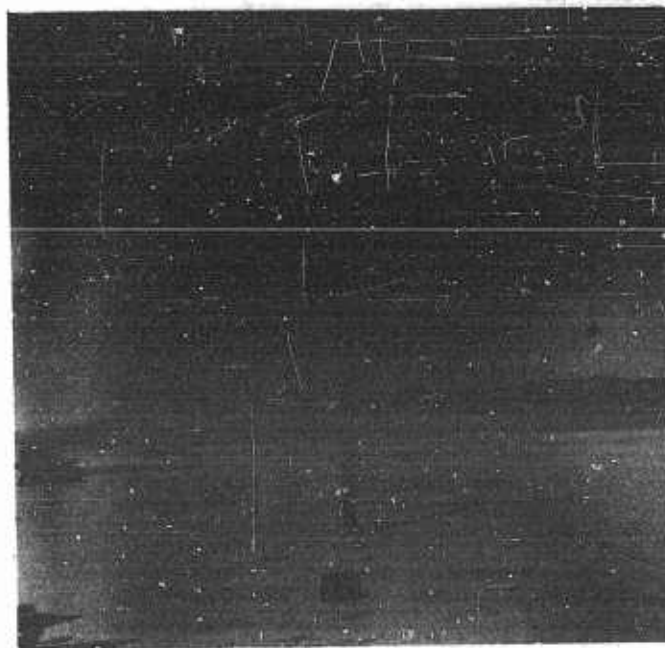
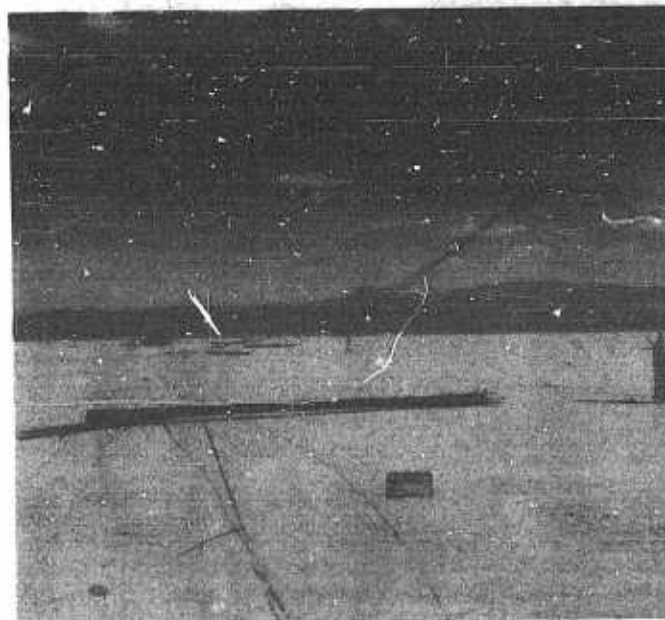
Fig. 3.39 Shot 9, Test Group 27, Transverse Pole Line, Poles B-1 through B-5, B-5 in Foreground. (Top-before, Bottom-after) 4450 ft, 35 cal, 7 psi.

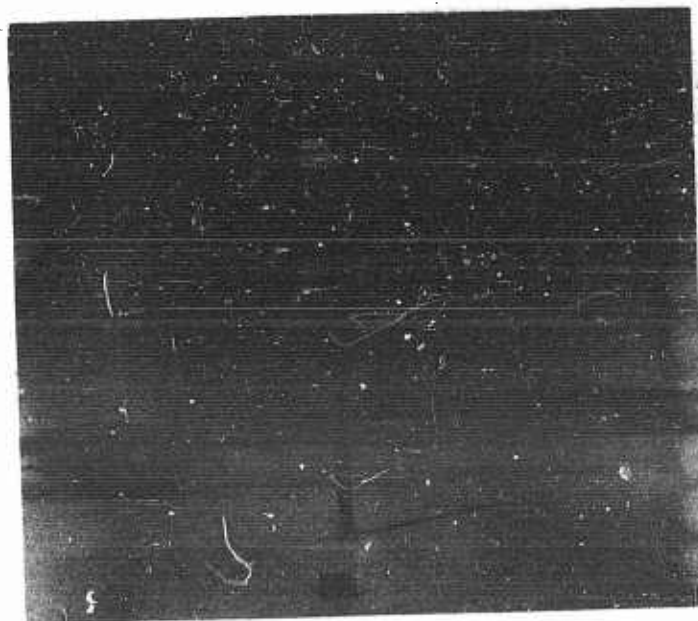
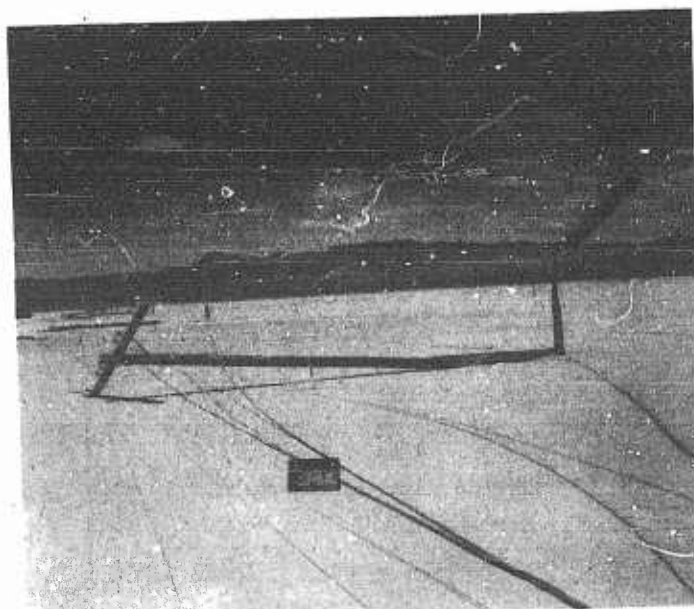
Fig. 3.40 Shot 9, Test Group 27, Transverse Pole Line, Poles B-1 through B-6, B-6 in Foreground. (Top-before, Bottom-after) 4450 ft, 35 cal, 7 psi.

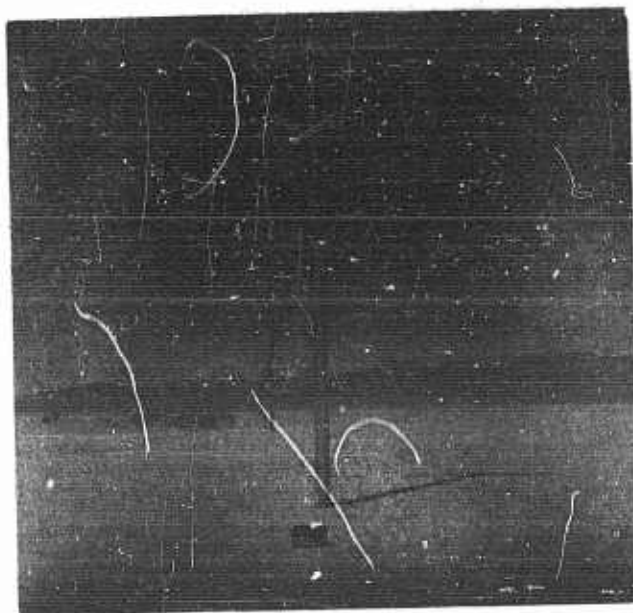
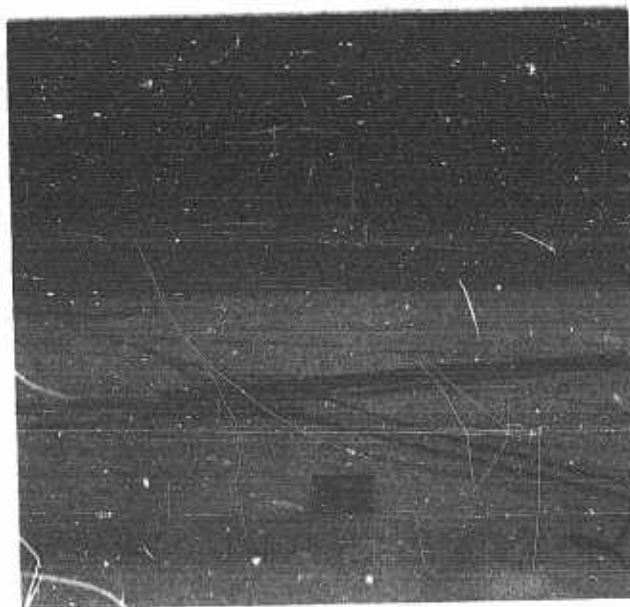
Fig. 3.41 Shot 9, Test Group 27, Transverse Pole Line, Poles B-1 through B-7, B-7 in Foreground. (Top-before, Bottom-after) 4450 ft, 35 cal, 7 psi.

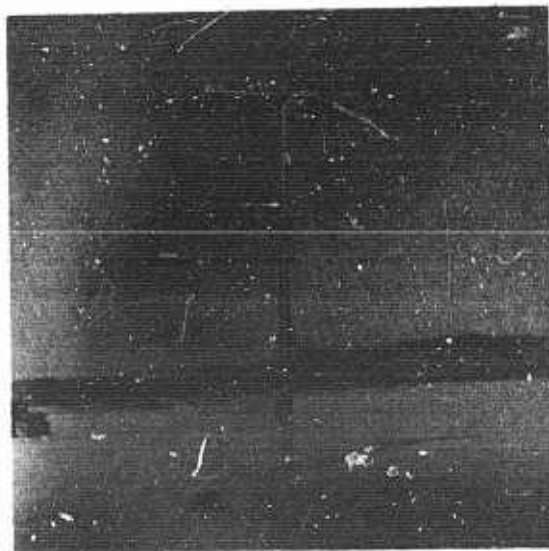
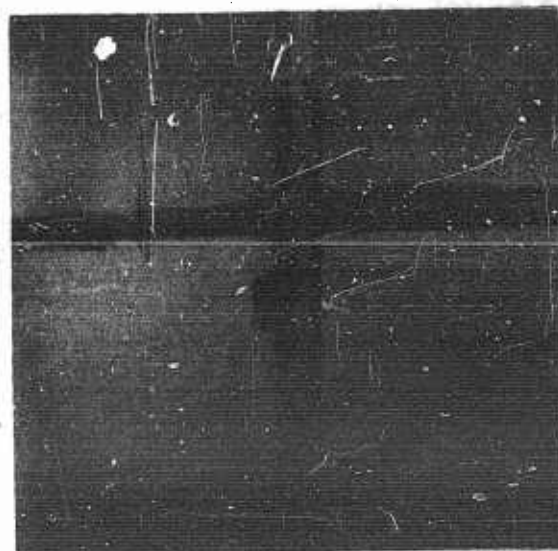
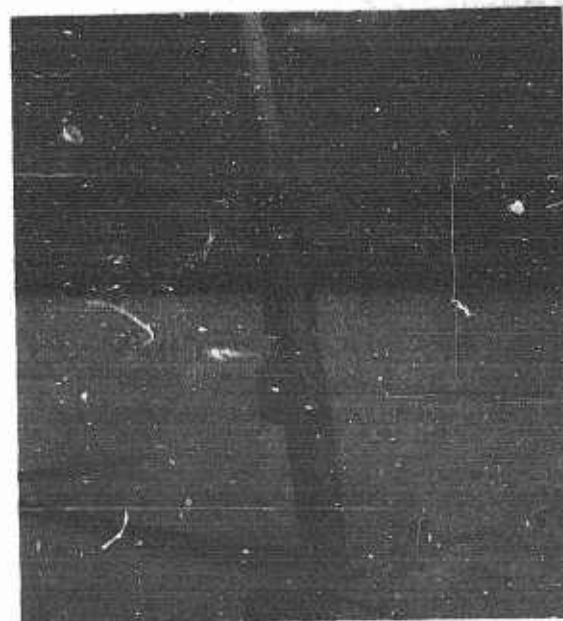
Fig. 3.42 Shot 9, Test Group 27, Transverse Pole Line, Poles B-1 through B-8, B-8 in Foreground. Right Shows Close-ups of EE-8 Telephone and TM-184 Terminal Strip on Shielded Side of Pole B-8. (Top left-before, Bottom left-after, Top right-before, Bottom right-after) 4450 ft, 35 cal, 7 psi.

(12) FIELD TELEPHONES: These items on poles B-1 and B-8 were shielded from the thermal flux and received no significant thermal or blast damage.

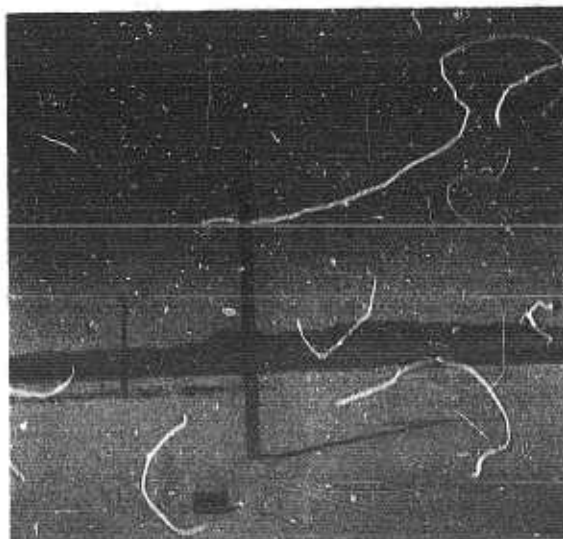
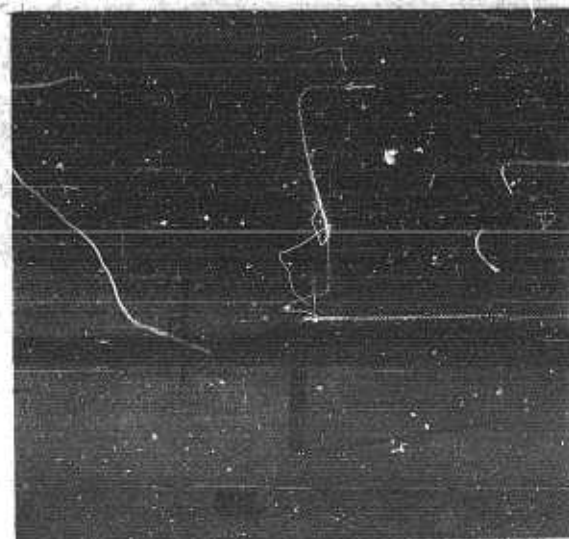
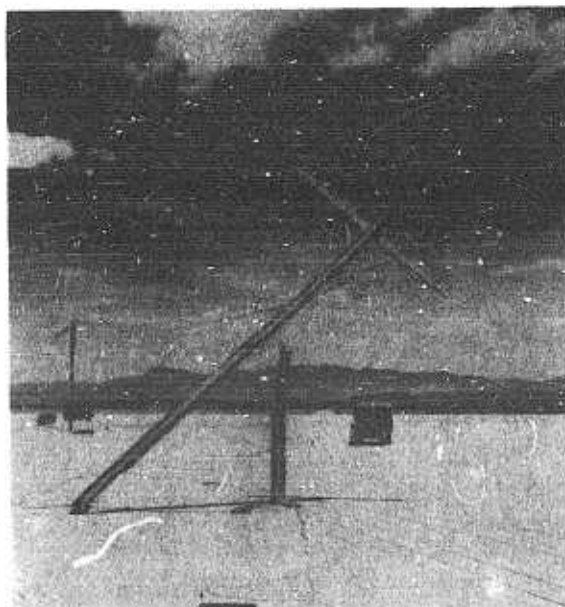
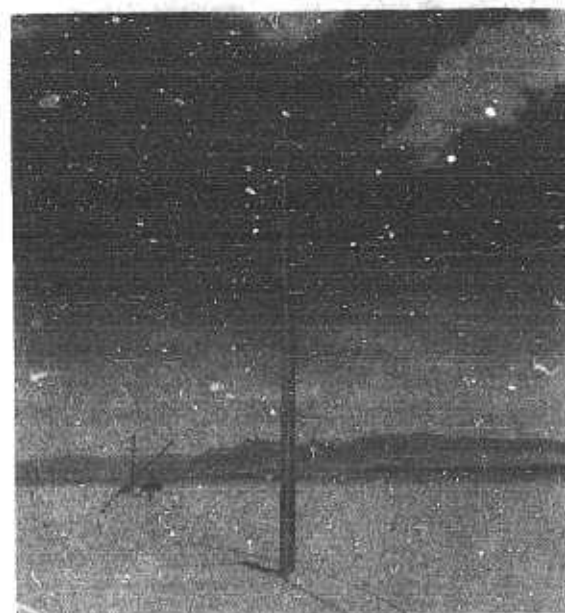
Fig. 3.45 Shot 9, Test Group 30,
Transverse Pole Line, Poles A-1
through A-2, A-2 in Foreground.
(Top-before, Bottom-after) 5425 ft,
25.5 cal, 5.6 psi.

Fig. 3.46 Shot 9, Test Group 30,
Transverse Pole Line, Poles A-1
through A-3, A-3 in Foreground.
(Top-before, Bottom-after) 5425 ft,
25.5 cal, 5.6 psi.

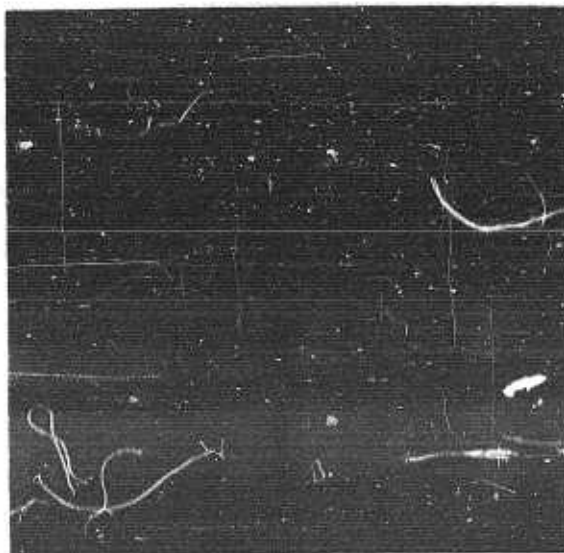
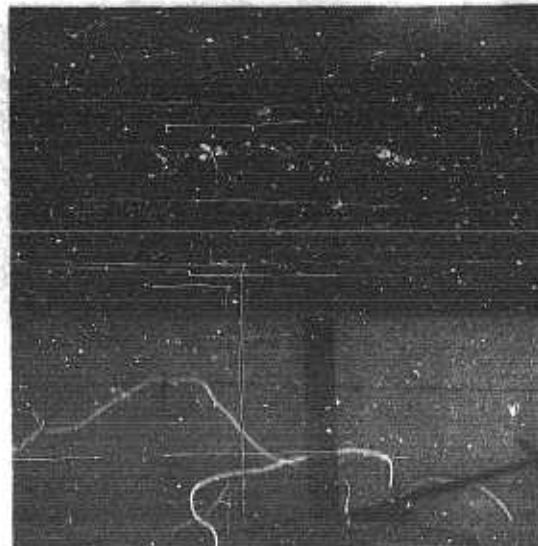
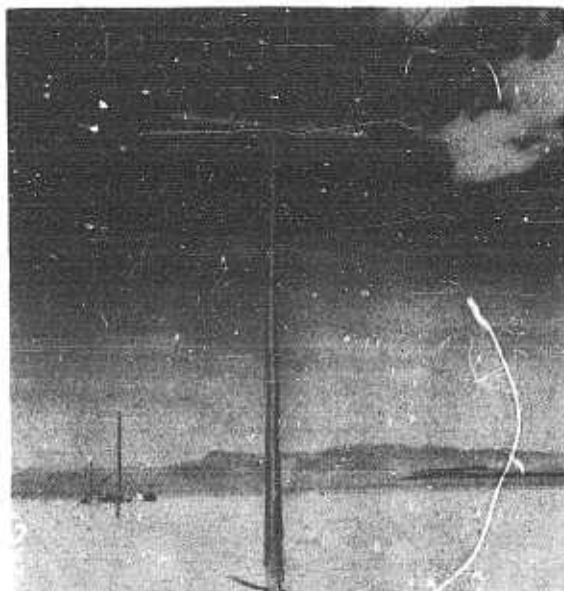
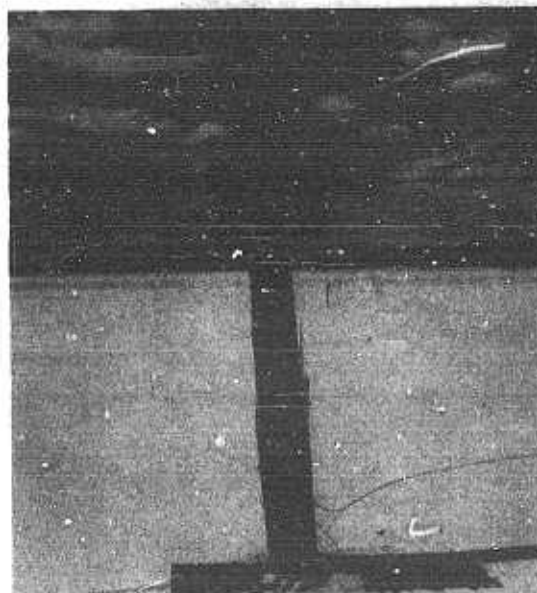
(11) CABLE TRANSFER RELAY: This relay on pole A-4 received no visible damage. A laboratory analysis indicates that this relay received no electrical or structural damage and it would have been serviceable.

Fig. 3.47 Shot 9, Test Group 30, Transverse Pole Line, Poles A-1 through A-4, A-4 in Foreground. (Top-before, Bottom-after)
Right - Close-ups of Cable Transfer Relay on Pole A-4.
(Top-before, Bottom-after) 5425 ft, 25.5 cal, 5.6 psi.

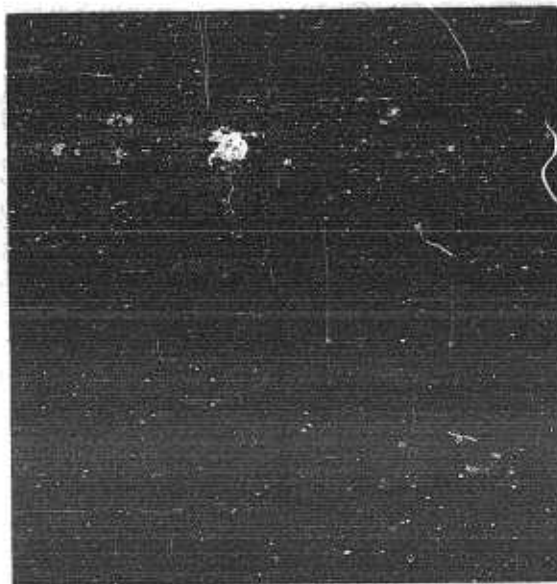
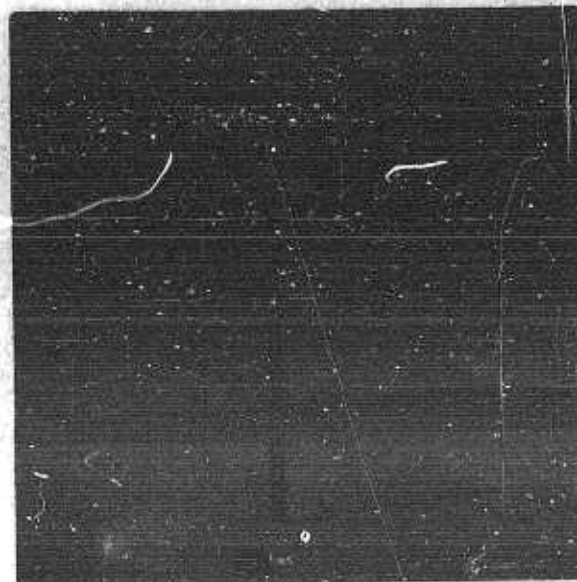
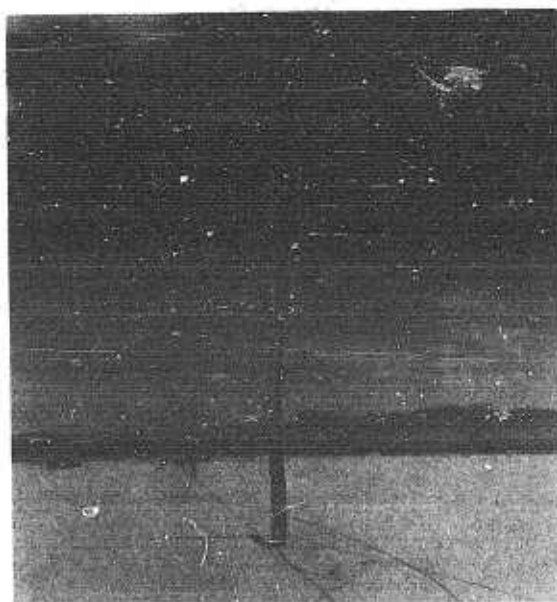
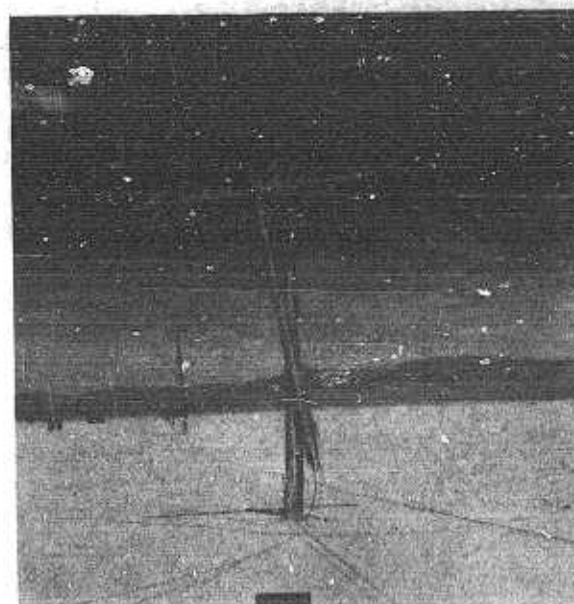
Fig. 3.48 Shot 9, Test Group 30,
Transverse Pole Line, Poles A-1
through A-6, A-6 in Foreground.
(Top-before, Bottom-after) 5425 ft,
25.5 cal, 5.6 psi.

Fig. 3.49 Shot 9, Test Group 30,
Transverse Pole Line, Poles A-1
through A-7, A-7 in Foreground.
(Top-before, Bottom-after) 5425 ft,
25.5 cal, 5.6 psi.

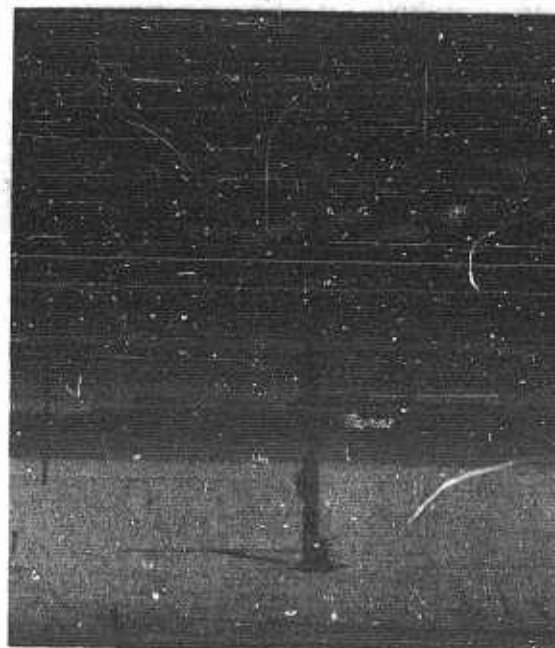
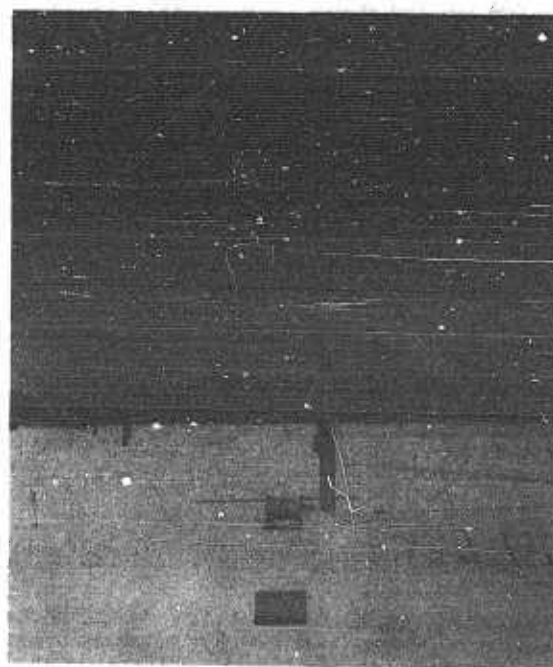
Fig. 3.50 Shot 9, Test Group 30, Transverse Pole Line, Poles A-1 through A-8, A-8 in Foreground. (Top-before, Bottom-after) 5425 ft, 25.5 cal, 5.6 psi.
